# SERVICE BULLETIN

EC14-002

February 14, 2014

## 2014 VERSA NOTE; MIL ON WITH DTC P059F STORED

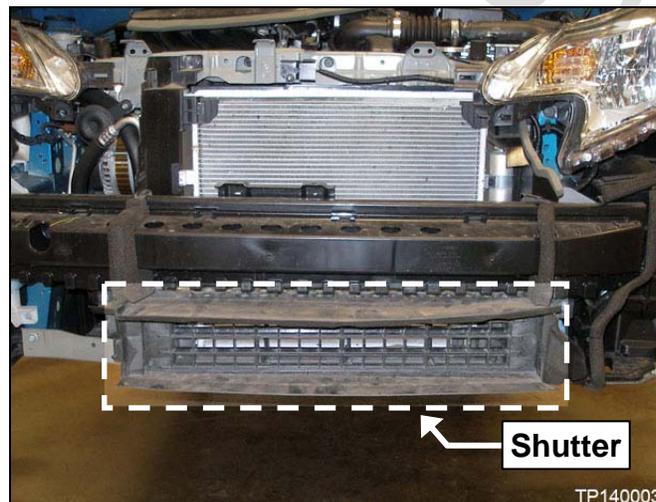
Figure GS3

3. Inspect the active grille shutter (shutter), remove any debris found (snow, trash, leaves, etc.).

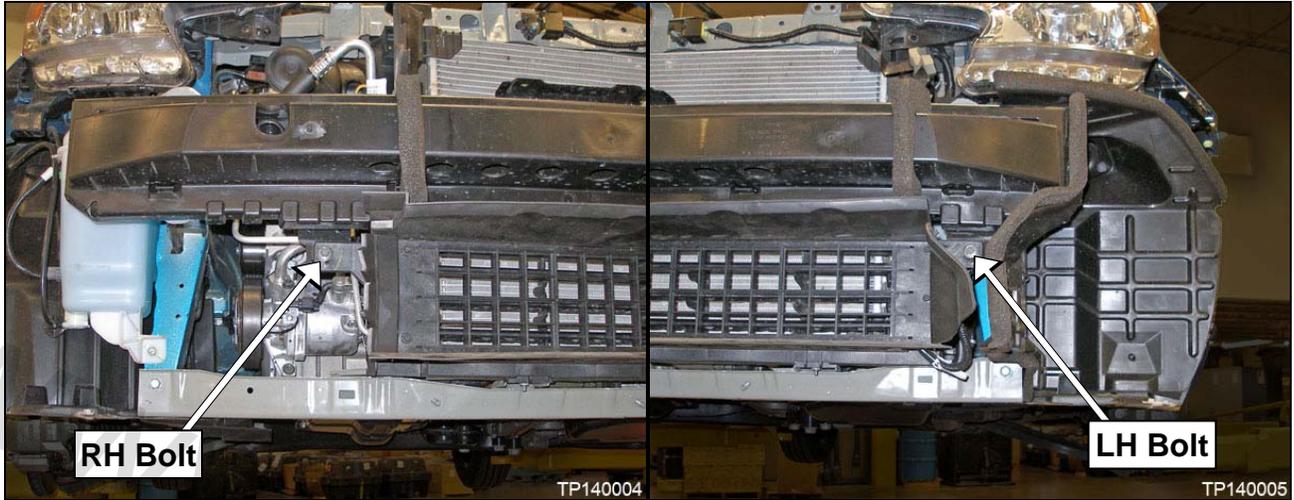
4. Inspect the shutter's installation for binding as follows:

a. Remove the two (2) bolts, one at each side (see Figure GS4 and GS5).

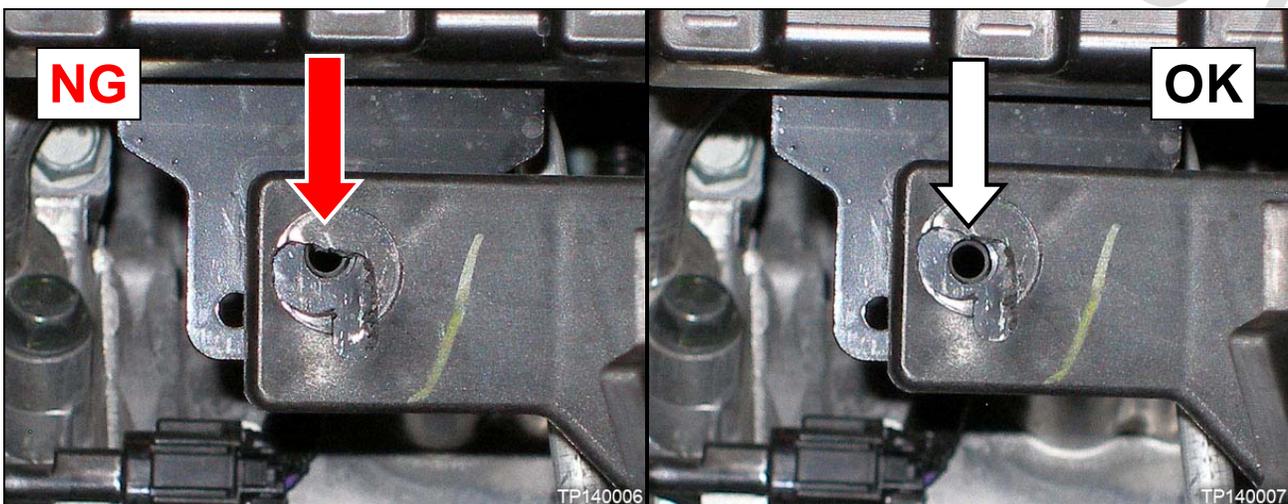
- c. If the bolts cannot be reinstalled easily (the bolt holes interfere - see Figure GS6 below), **go to Active Grille Shutter Adjustment on the next page.**

- d. If the bolts can be reinstalled easily (see Figure GS7):
- aa. Reinstall the shutter bolts.
    - Shutter bolts torque: 5.5 N•m (0.56 kg-m, **48.7 in lbs**)
