# SERVICE BULLETIN

EC14-002

February 14, 2014

## 2014 VERSA NOTE; MIL ON WITH DTC P059F STORED

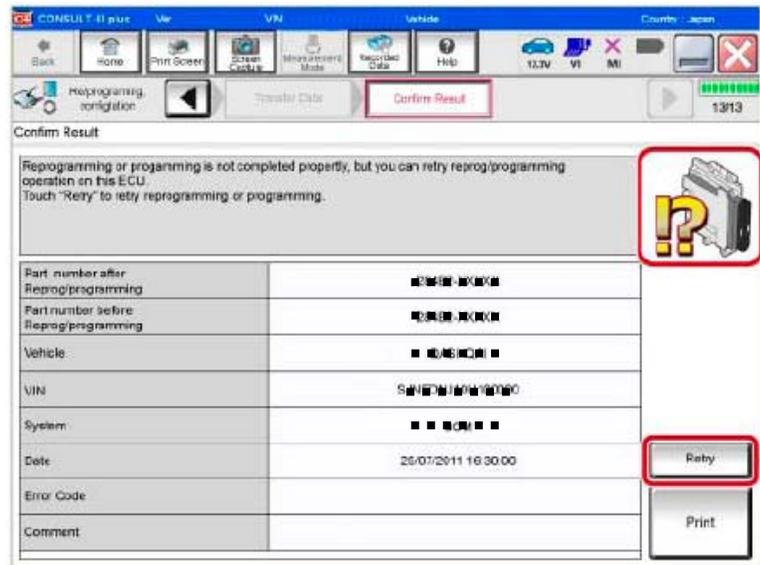
Figure 5

If reprogramming does not complete and the “!?” icon displays as shown in Figure 5:

- Check battery voltage (12.0–15.5 V).
- Ignition is ON, engine OFF.
- External Bluetooth® devices are OFF.
- All electrical loads are OFF.
- **Select retry and follow the on screen instructions.**
- “Retry” may not go through on first attempt and can be selected more than once.

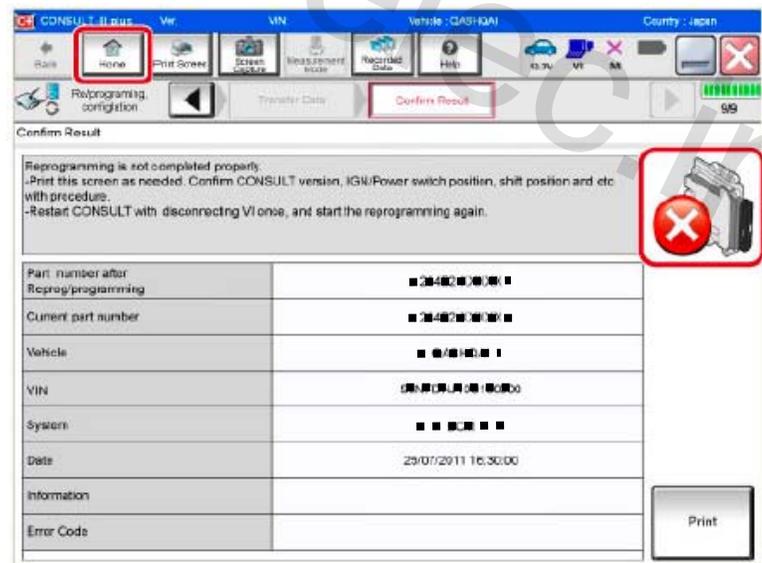
Figure 6

If reprogramming does not complete and the “X” icon displays as shown in Figure 6:

- Check battery voltage (12.0 – 15.5 V).
- CONSULT A/C adapter is plugged in.
- Ignition is ON, engine OFF.
- Transmission is in Park.
- All C-III plus / VI cables are securely connected.
- All C-III plus updates are installed.
- **Select Home, and restart the reprogram procedure from the beginning.**
